•	CIA IMAGERY ANALYSIS DIVISION					
•	NAME		- 1	COUNTRY	COORDINATES	
25X1D	Ron Highway Br.			17 52N - 106 27E		
	Bridge No. 9 on NE 48-11		North Vietnam	XE 533770		
	REFERENCES			BRIEF NO:	_	
	PHOTO				A	
	MAP	AMS L509	NE 48-1	1	PIB - 65035	
•	LOCATION:	1.0 nm S.W.	of Ron on ar	unnumbered route.		_

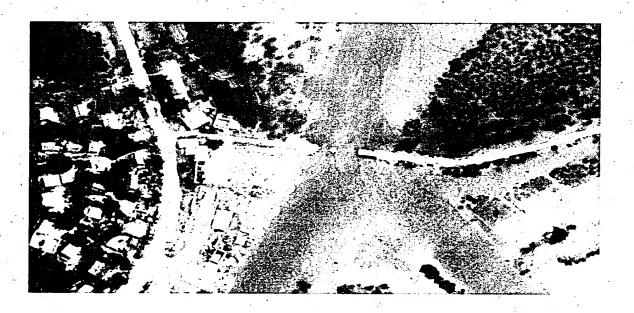
Two spans completely destroyed, two spans heavily damaged

COMPENSATIVE ACTION: None
